THE VIEQUES
CONSERVATION
AND HISTORICAL
TRUST

SUBJECT: Report: Visual Inspection of how the erosion and sedimentation control remedy implemented under Assistance Agreement X797210301 managed rain and runoff during tropical storm Erika

Site Visit report: Visual Inspection of Tropical Storm Erika effects on implemented remedy Puerto Mosquito Erosion and Sedimentation Control Project developed under Assistance Agreement X797210301

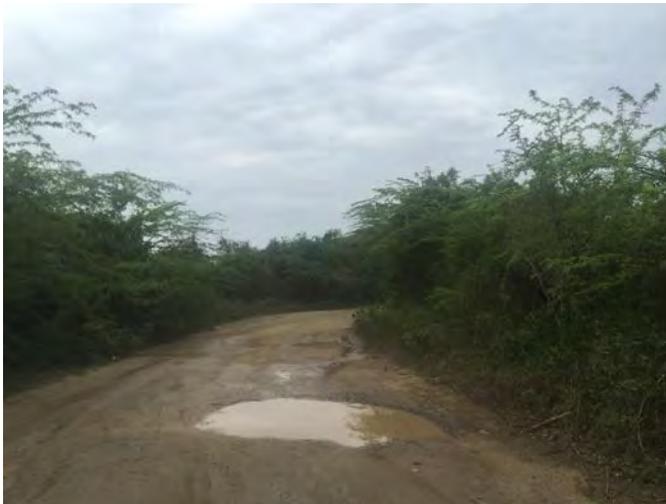
Photo 1. This is the beginning portion of the road. This area was not part of the erosion control project. Notice the water-created depressions.

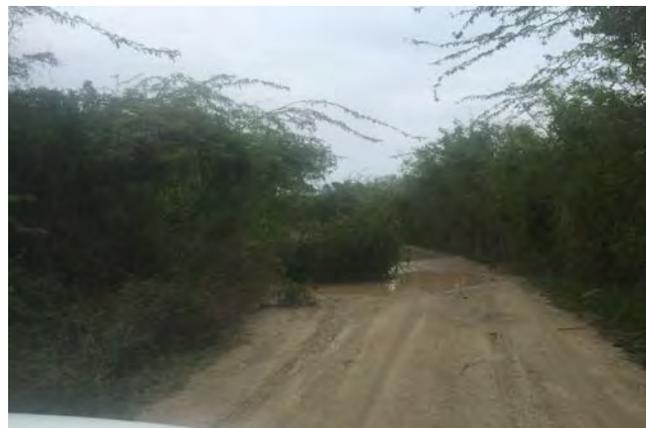
Photo 2. Fallen tree on road next to water puddles at beginning of the access road. Also not part of the project.

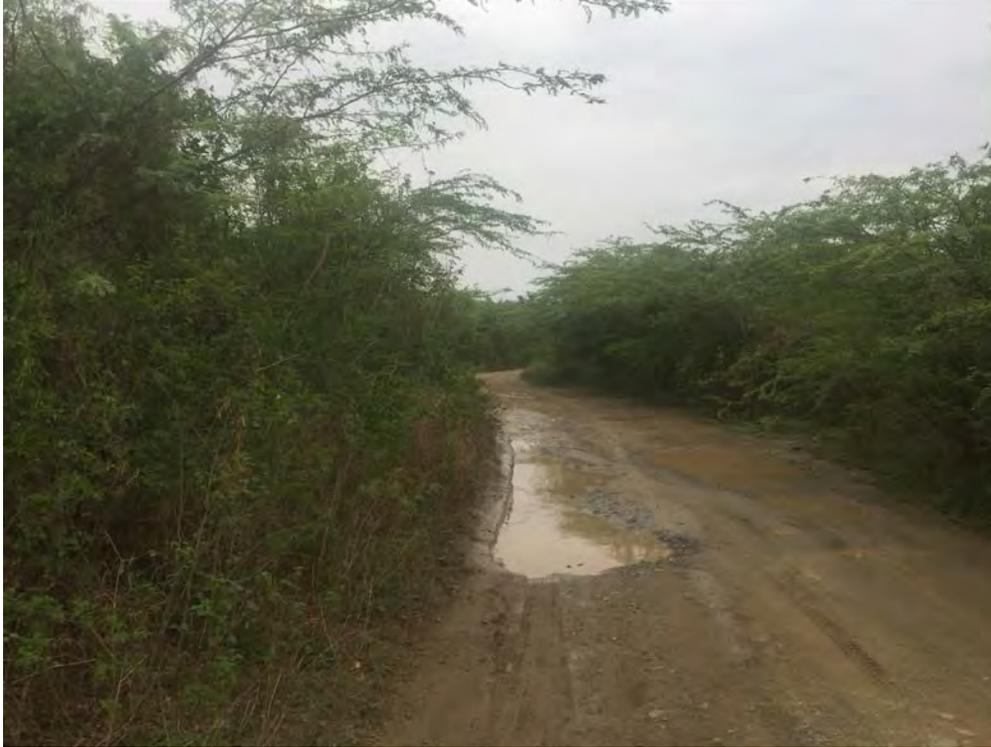
Photo 3. Puddles and deposited sediment on the road.

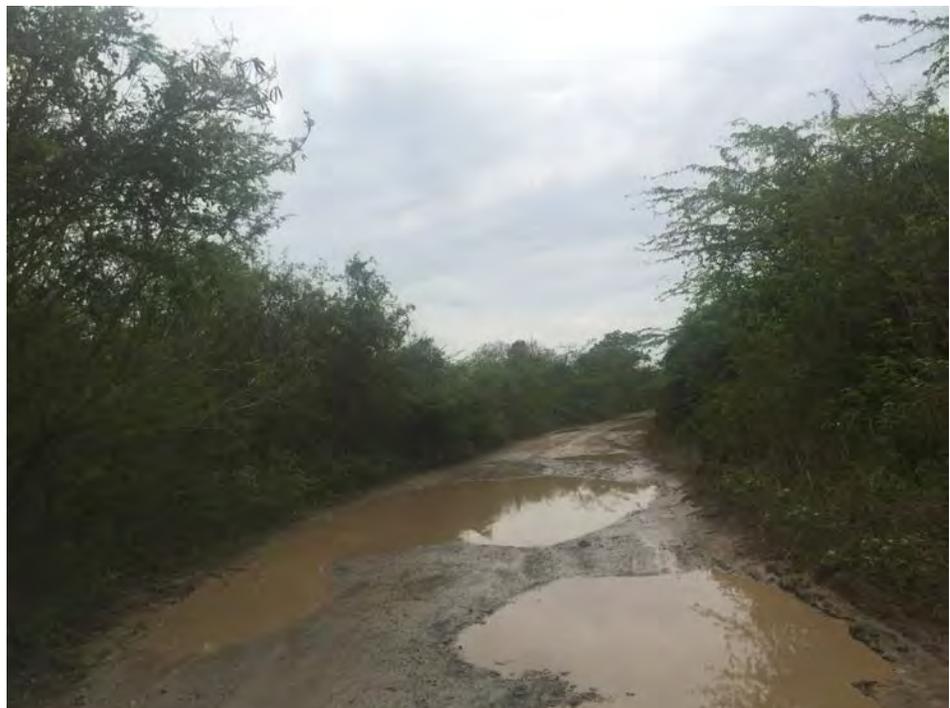
Photo 4. Larger water and sediment deposits on the access road area just before the start of the remedied section of the road.

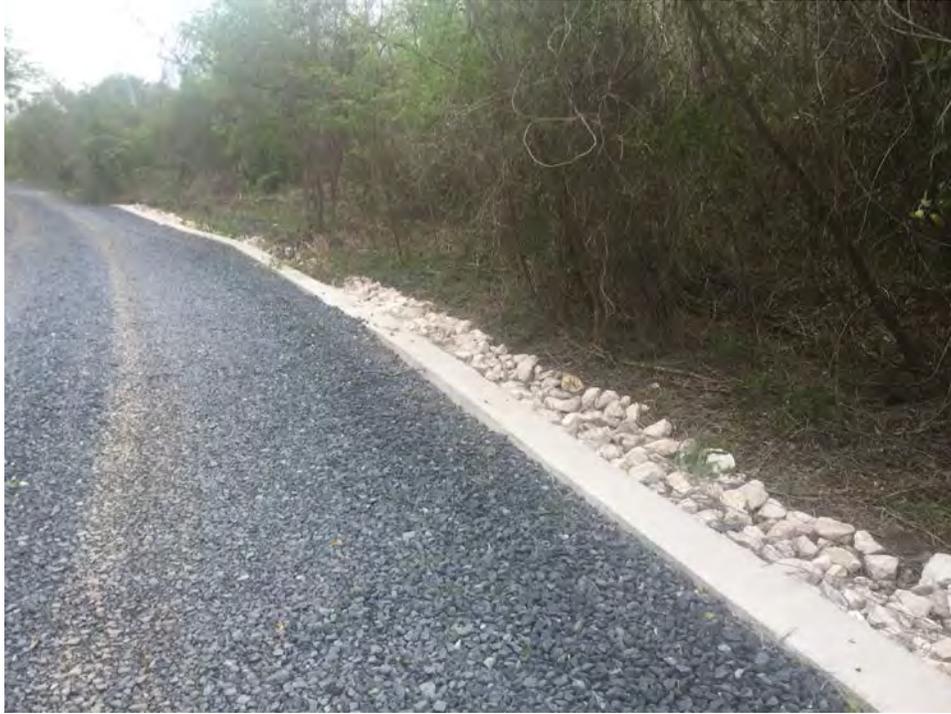
Photo 5. Beginning of access road green infrastructure sediment and erosion control.

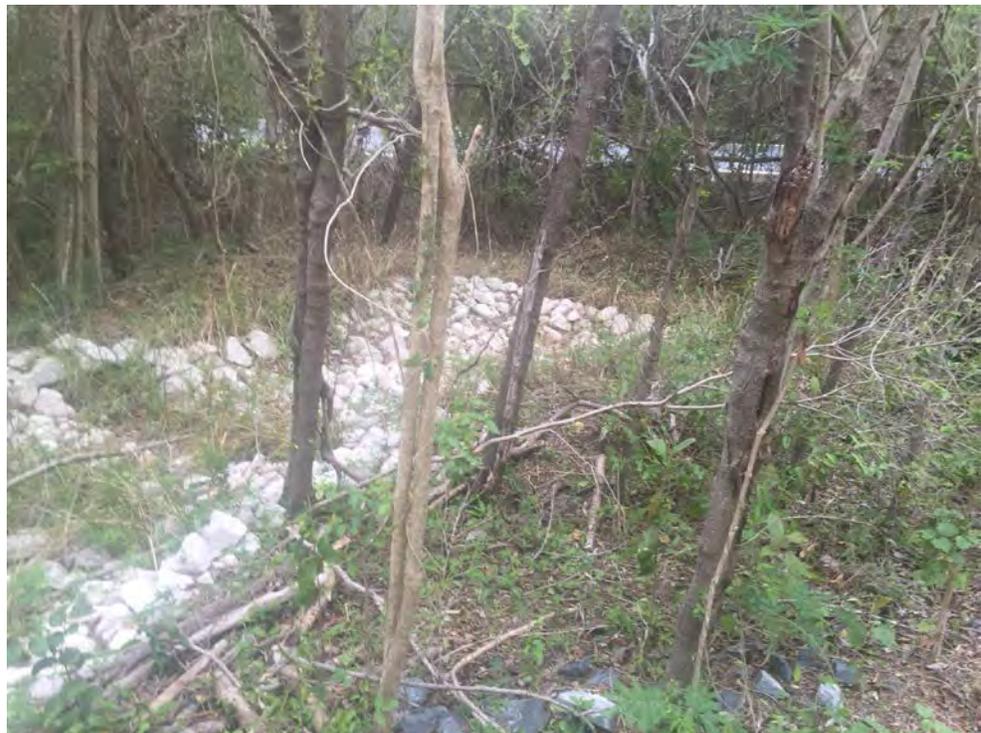
Photo 6. Vegetated sediment trap on connecting road to Panteón beach; it was free of sediment which demonstrates it is working properly.

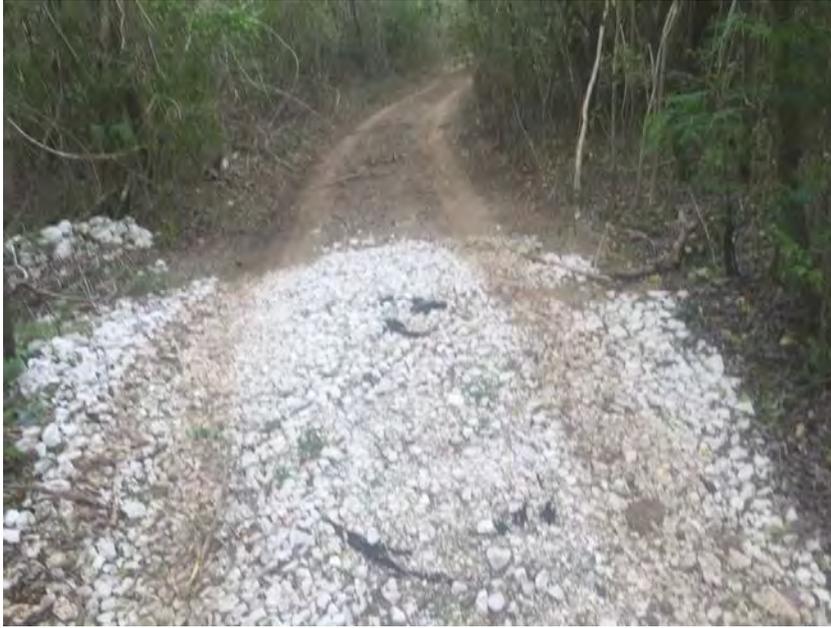
Photo 6. Check dam on connecting road to Panteón beach. This is the steepest road and of highest elevation. It was identified as the main producer of sediments and runoff speed during substantial precipitation events.

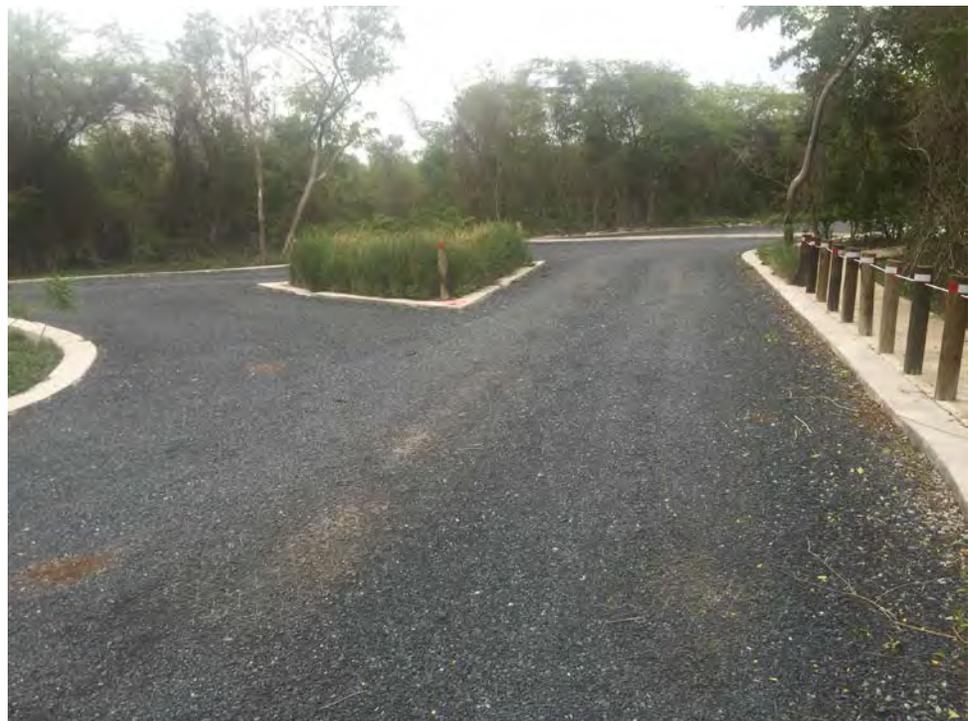
Photo 7. Remedied road to the Bay with permeable pavement and rain gardens to the sides and center. The area was dry and showed no signs of damage.

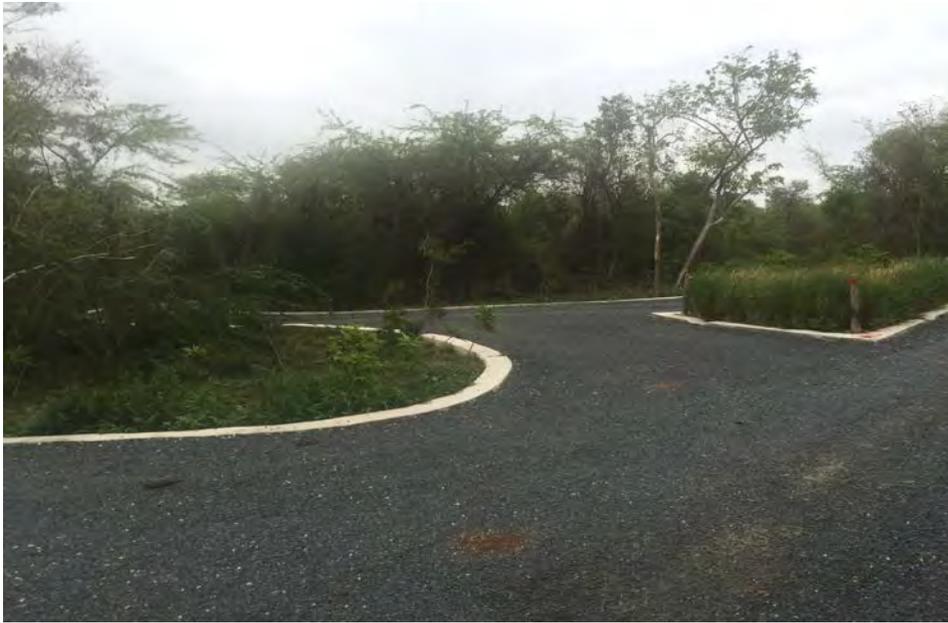
Photo 8. Turnaround area with rain gardens. With the exception of some small plants the vegetation appeared to receive little to no damage.

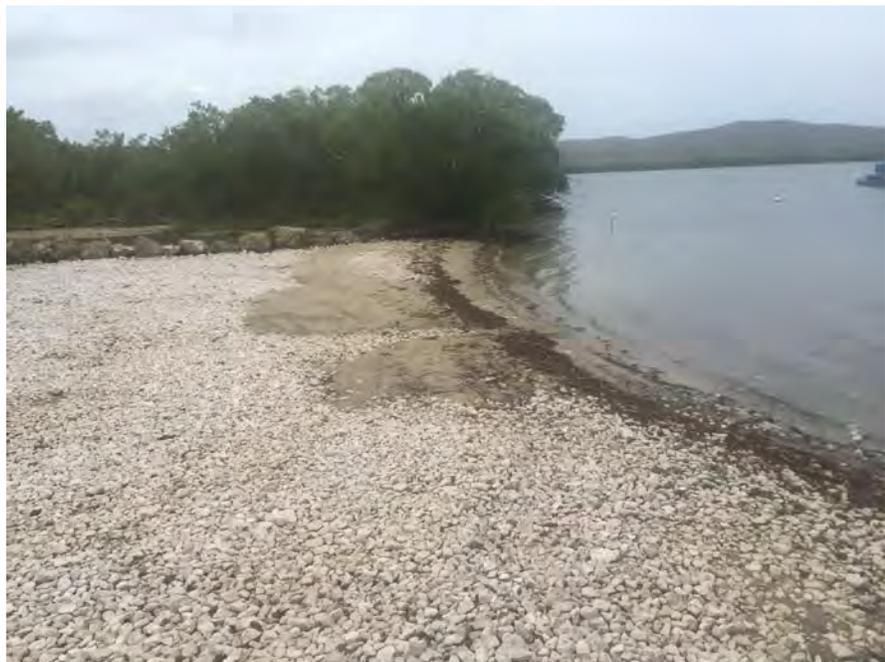
Photo 9. Shoreline of Puerto Mosquito. This is a heavy traffic area, as it is a kayak and boat drop-off area as well as the embarking and disembarking point for the nighttime tours to the Bay. A large amount of sediments used to accumulate in area before the remedy was implemented.

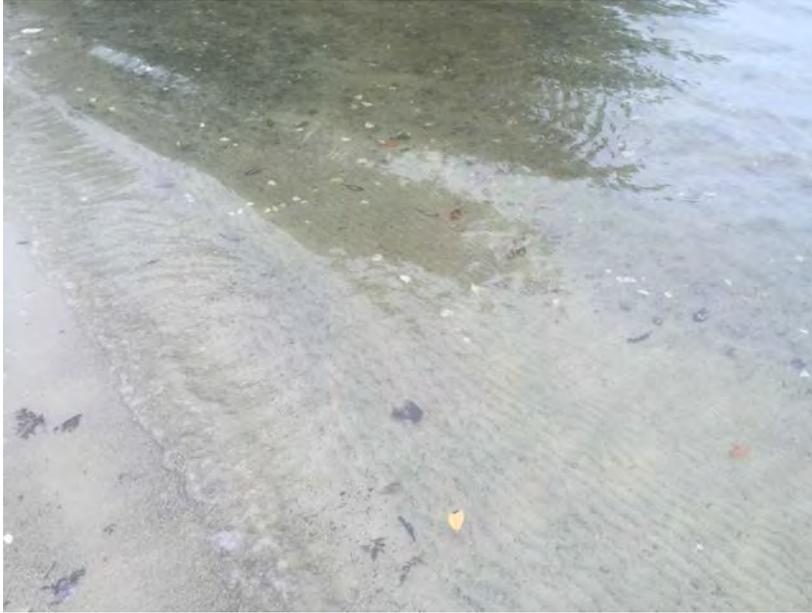
Photo 10. Water on shoreline was very clear.

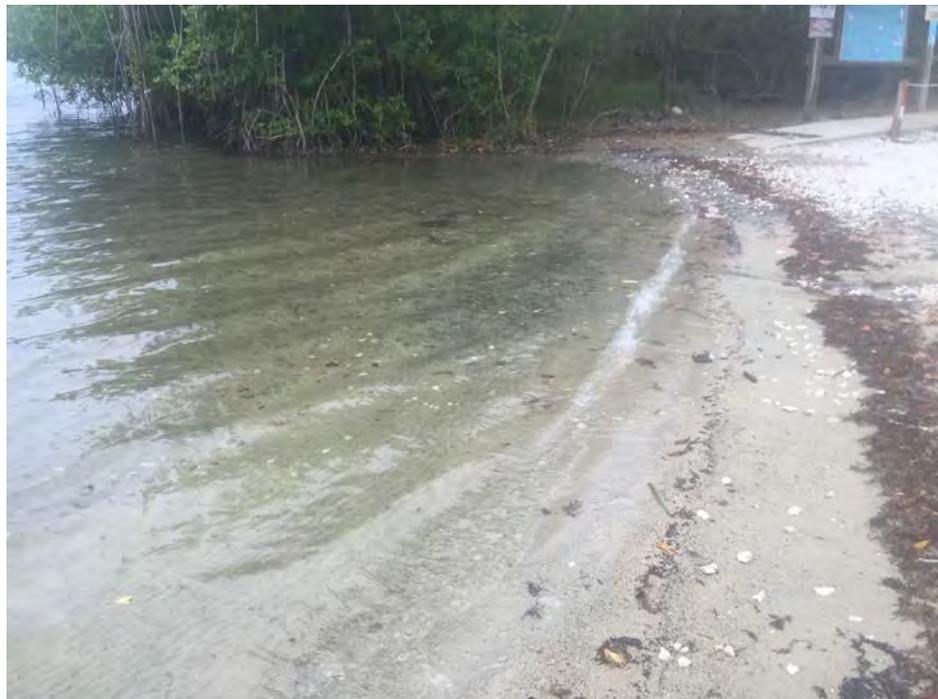
Photo 11. Water on the shoreline appears to have very little signs of sediments; it is very clear in comparison to past observations during storm events. The absence of the white rocks used to remedy the shoreline embarking and disembarking area suggests a controlled flow of water and sediment.

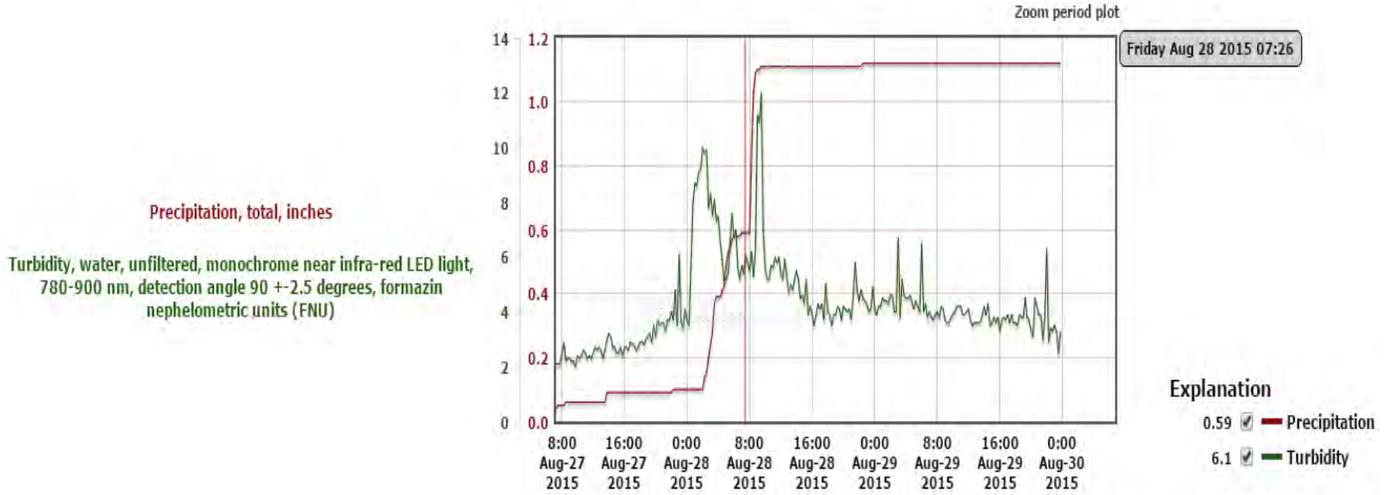
Graph #1 Turbidity/Precipitation

We can observe that the turbidity spike correlates to the precipitation event. Notice a relatively fast recovery from the spike.

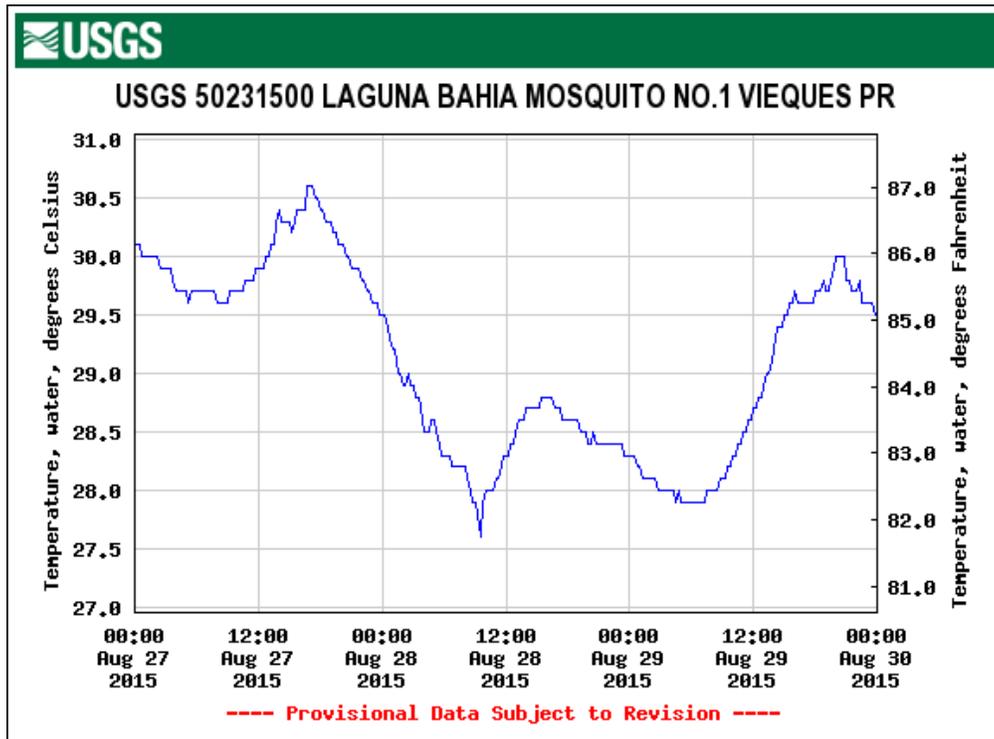
Graph #2. Temperature. The temperature dropped 3 degrees Celsius.

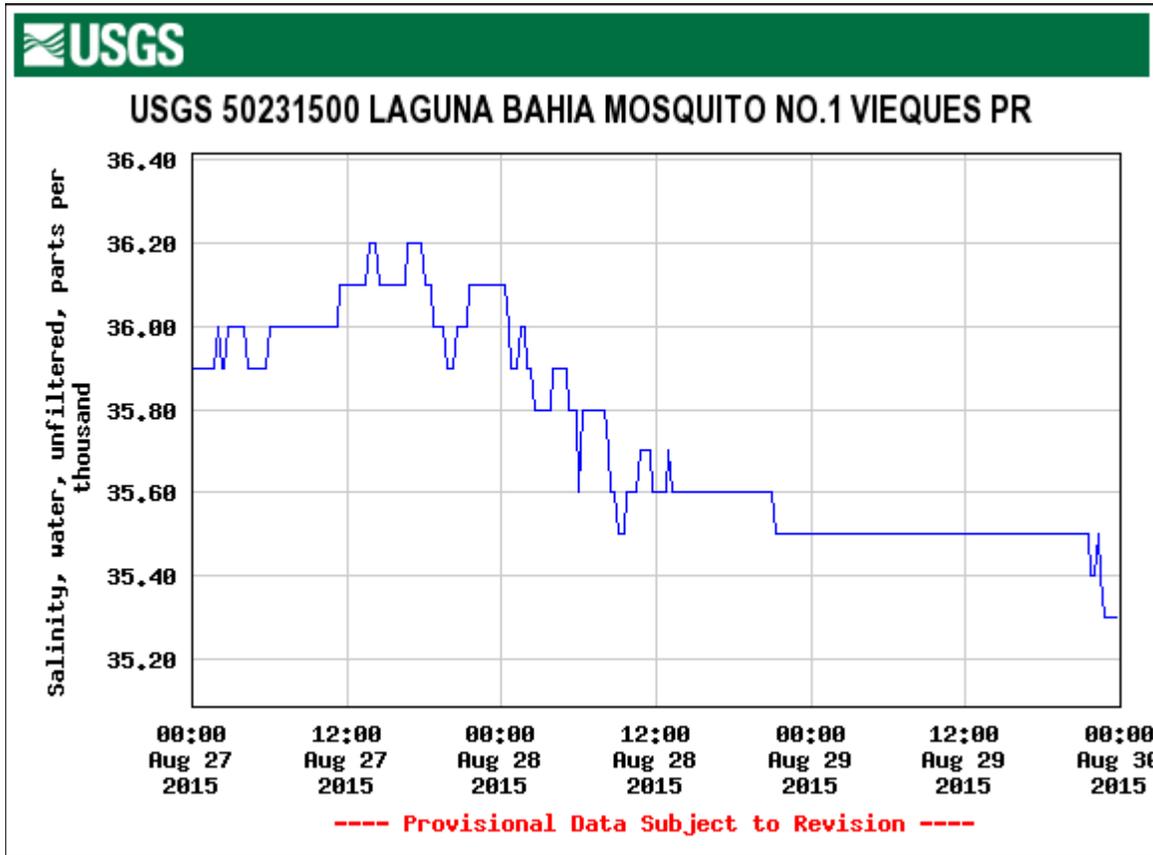
Graph #3. Salinity. The salinity drop relates to freshwater entering the Bay by way of rain and access points and hydrological strain
s.

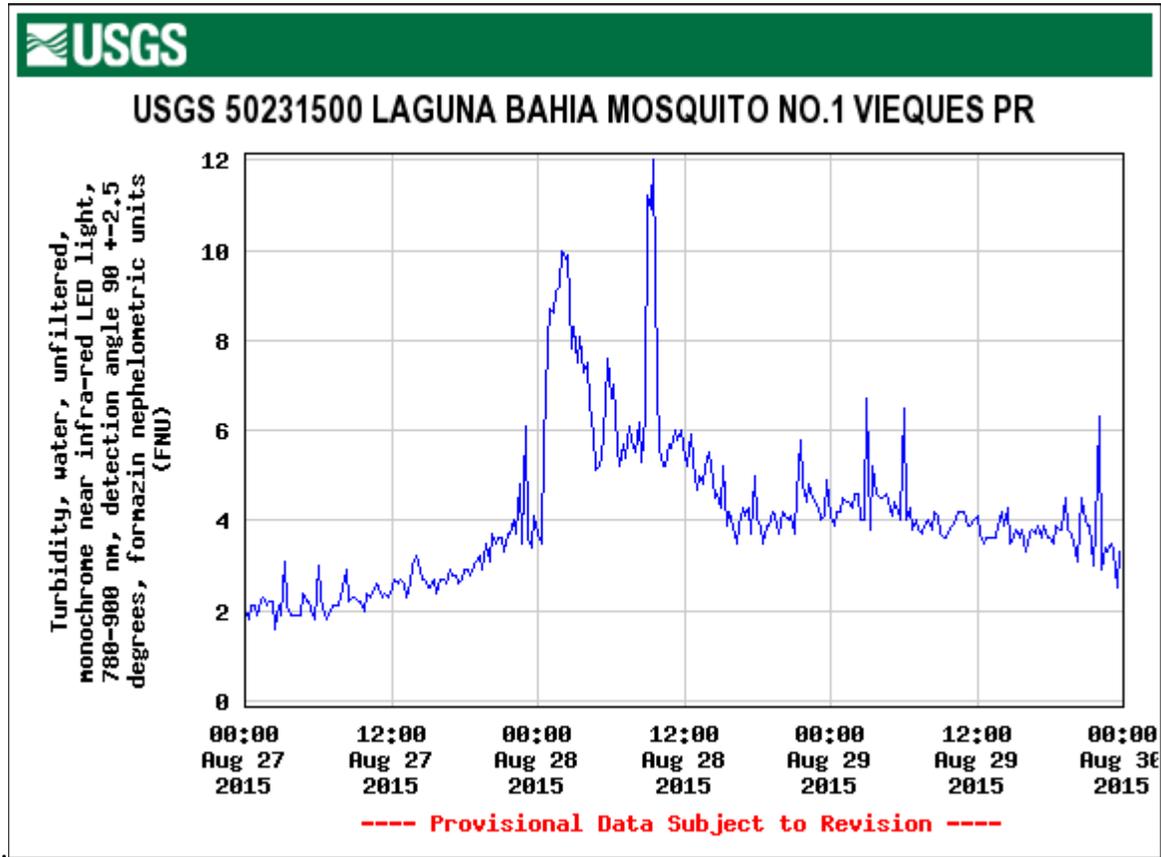
Graph #4. Turbidity. 5.0 is considered to be an indicator for higher turbidity than normally found
