THE VIEQUES
CONSERVATION
AND HISTORICAL
TRUST

SUBJECT: Report: Visual Inspection of how the erosion and sedimentation control remedy implemented under Assistance Agreement X797210301 managed rain and runoff during tropical storm Erika

Site Visit report: Visual Inspection of Tropical Storm Erika effects on implemented remedy Puerto Mosquito Erosion and Sedimentation Control Project developed under Assistance Agreement X797210301

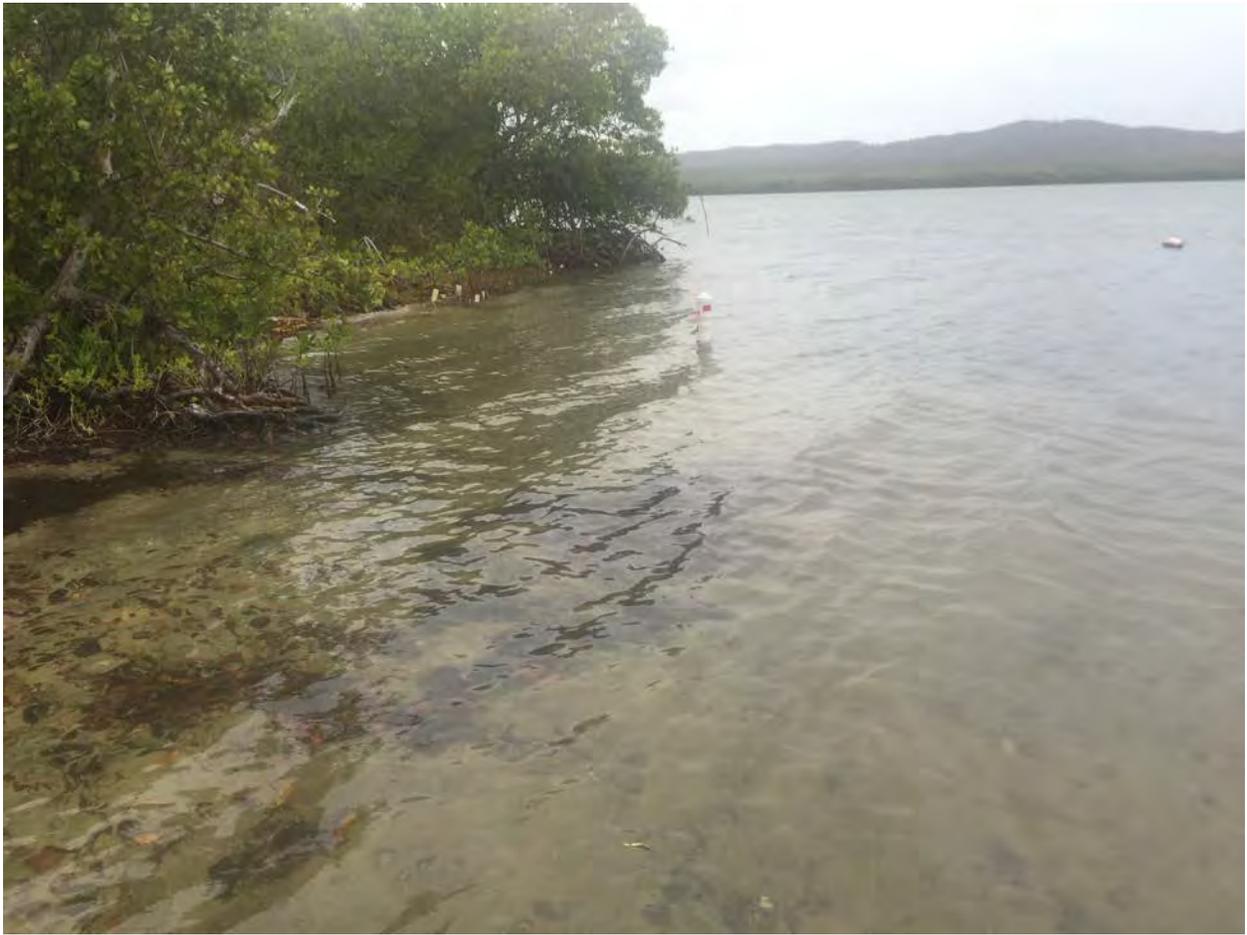
Photo 11. Water on the shoreline appears to have very little signs of sediments; it is very clear in comparison to past observations during storm events. The absence of the white rocks used to remedy the shoreline embarking and disembarking area suggests a controlled flow of water and sediment.

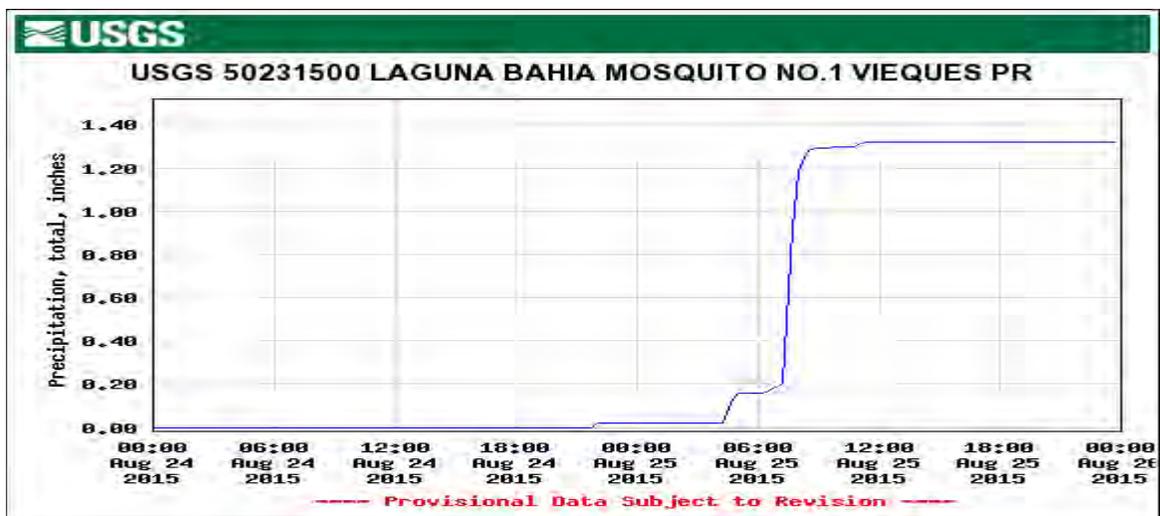
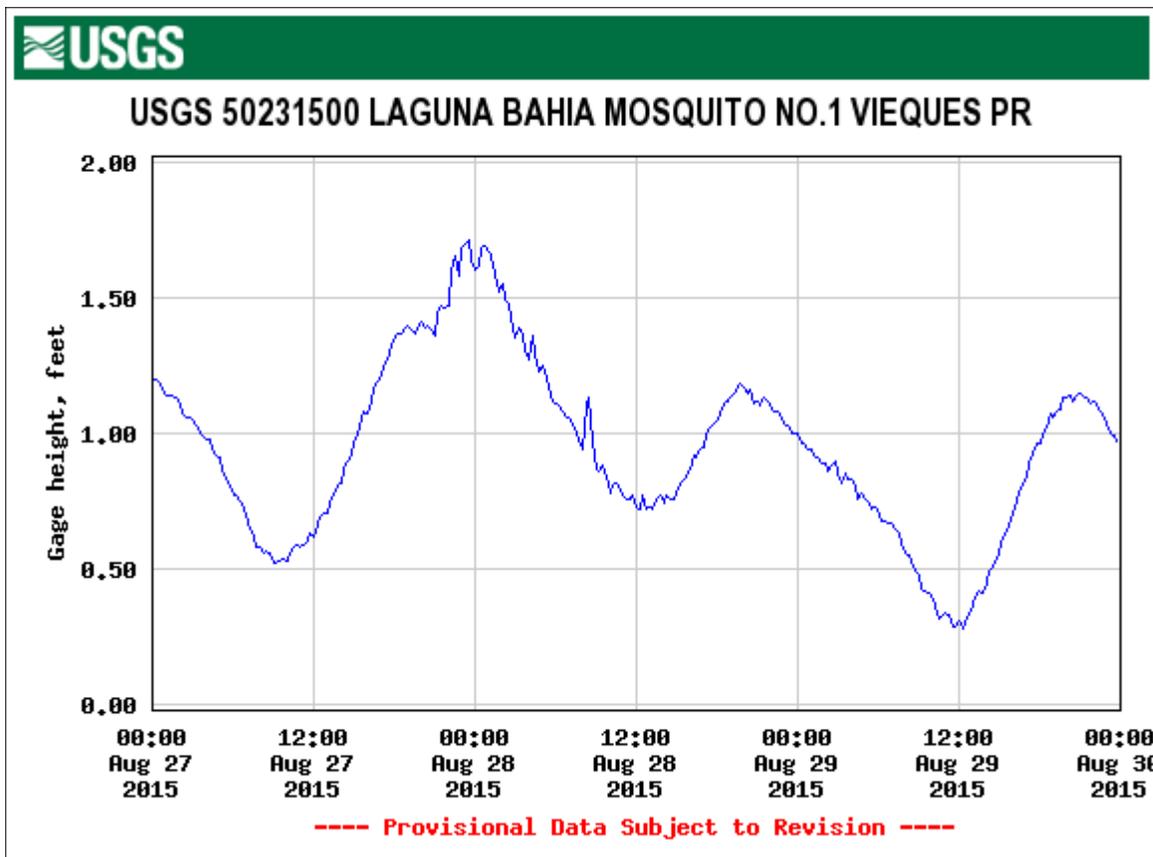
Graphs #5a and 5b. Reference for rain event. Not including rain event at the beginning of the same week. Below the rain event of 8/25/15.

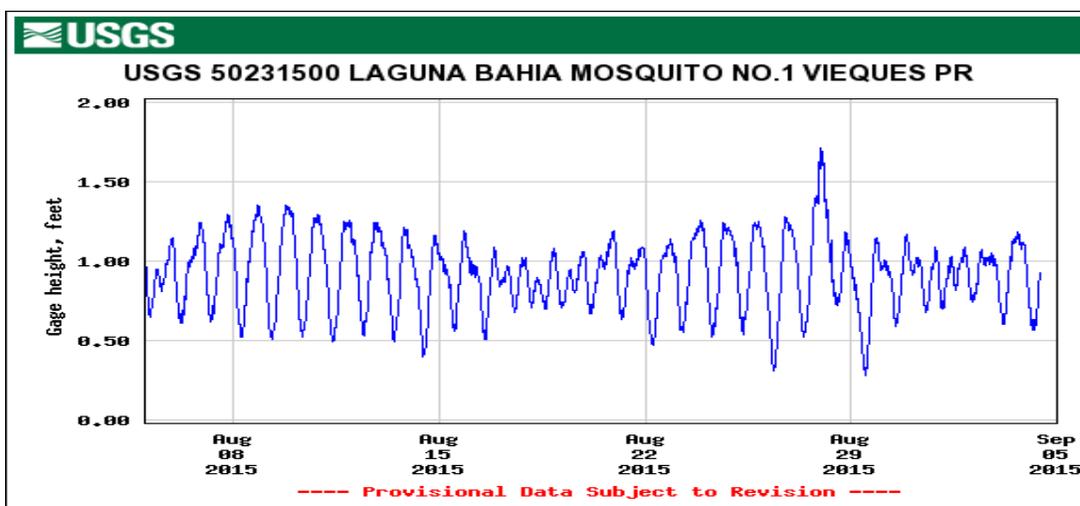
Graphs 6a and 6b. Gage height

The gage height is included to reference water exchange by tidal exchange and water coming onto the Bay from precipitation. The fluctuation is presented in 72 hour period (above) and 30 days (below) period.
